NATIONAL TRANSPORTATION SAFETY BOARD

AIRCRAFT ACCIDENT REPORT

IN-FLIGHT LOSS OF CONTROL AND
SUBSEQUENT COLLISION WITH TERRAIN
CESSNA 177B, N35207
CHEYENNE, WYOMING
APRIL 11, 1996

**Adopted: March 11, 1997
Notation 6814**

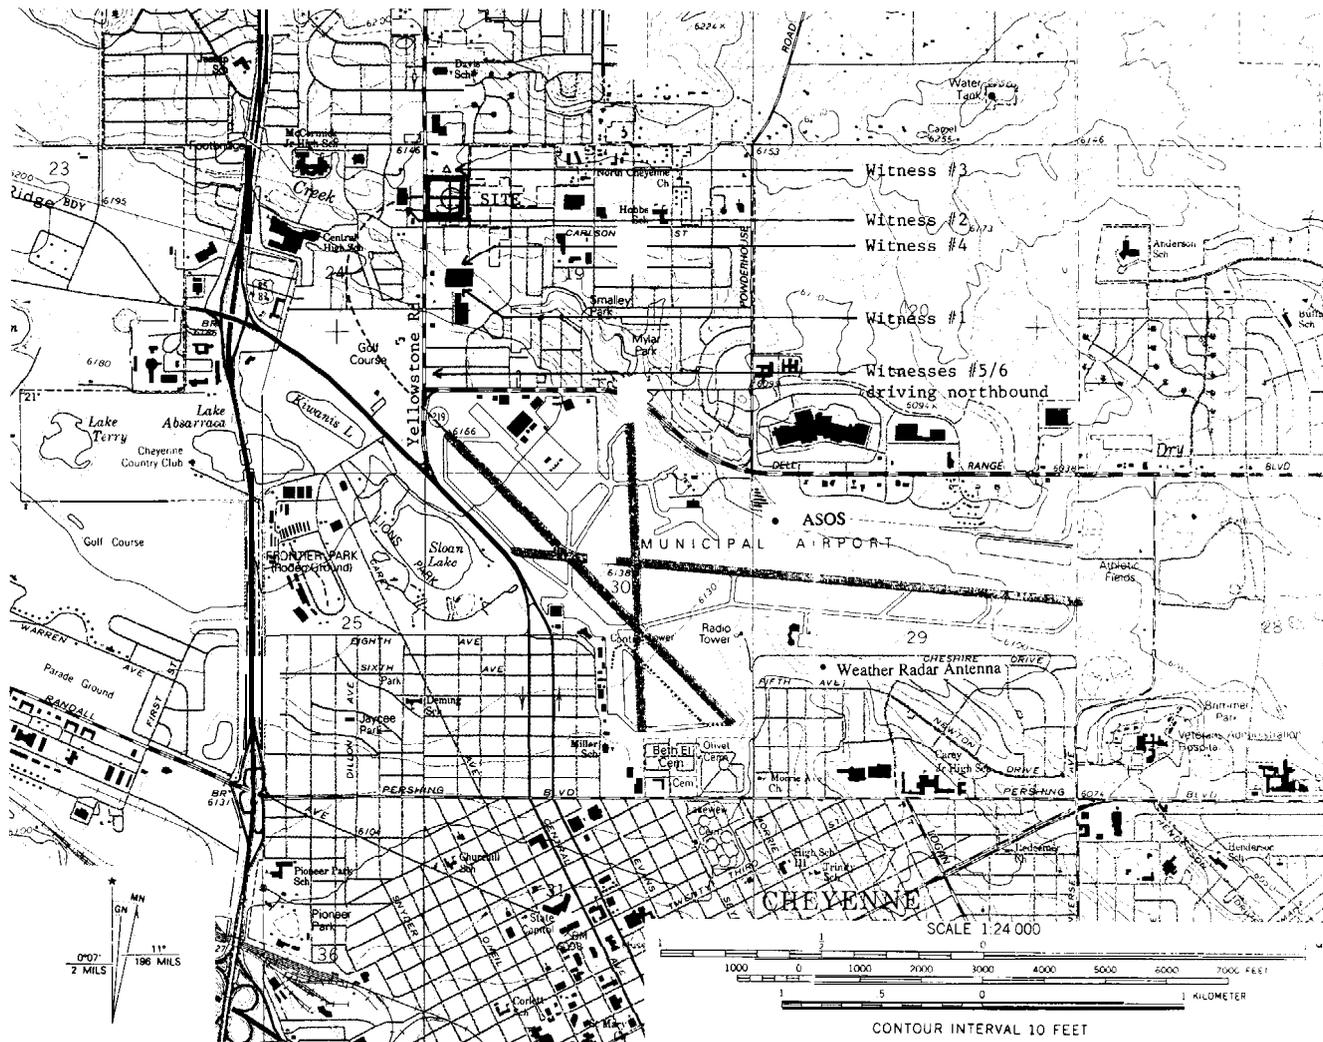
Figure 1.--Map depicting airplane ground track and airport.

Ground witnesses observed the airplane depart the upwind end of runway 30 heading in a northwesterly direction, and then execute a gradual right turn to an easterly heading. The witnesses generally described the airplane as having a low altitude, low airspeed, a high pitch attitude and wobbly wings. As it was rolling out of the right turn, at several hundred feet agl,¹⁰ the airplane was observed to rapidly descend to the ground in a near-vertical flightpath. The impact occurred approximately 4,000 feet north of the departure (upwind) end of runway 30 in a residential neighborhood.

Eyewitnesses who observed all or part of the accident sequence reported that the weather conditions at that time were windy, with moderate to heavy mixed precipitation (rain, snow, and sleet), thunder and lightning. (Locations of eyewitnesses are noted on Figure 1.)

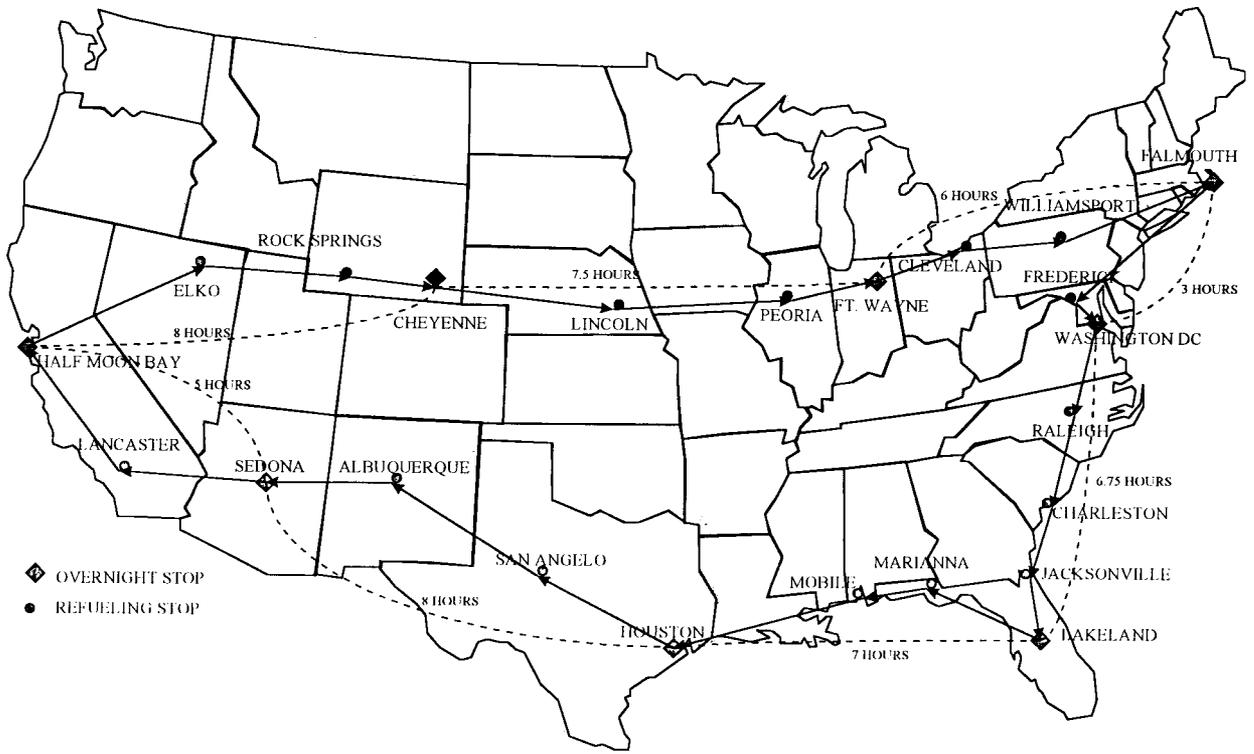
Figure 3.--Proposed route of flight.

The following chart displays the intended route of flight and projected daily flight times, as contained in an itinerary sheet found in the aircraft wreckage:

The Safety Board concludes that the itinerary was overly ambitious, and that a desire to adhere to it may have contributed to the pilot in command's decision to take off under the questionable conditions at Cheyenne.
